TOWN OF EASTEND
WTP, RAW WATER RESERVOIR & INTAKE UPGRADES

BCL File #103.02-7B
August 7, 2020

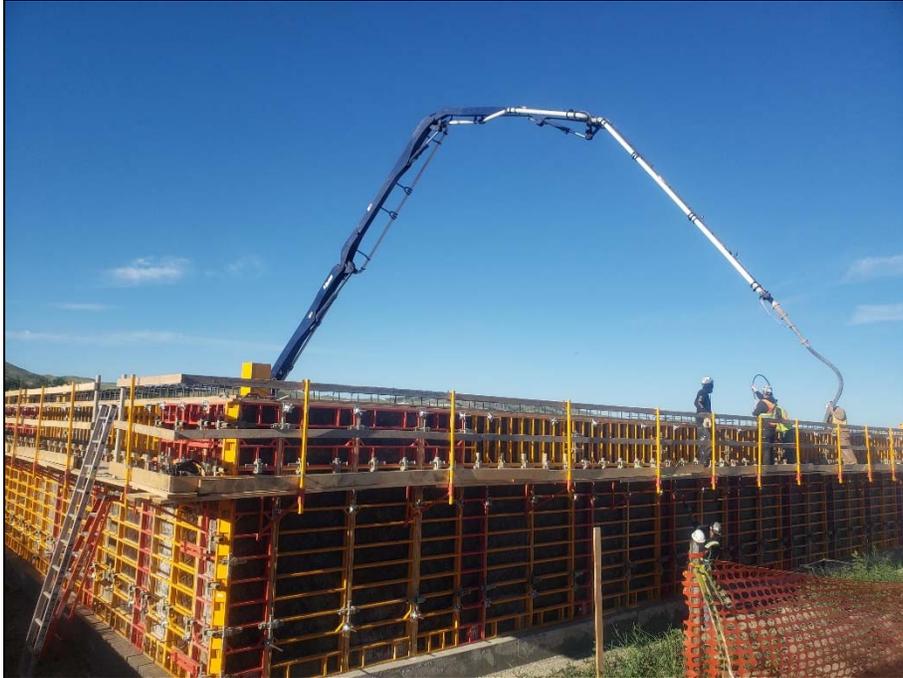
Wall concrete pour – pump truck.

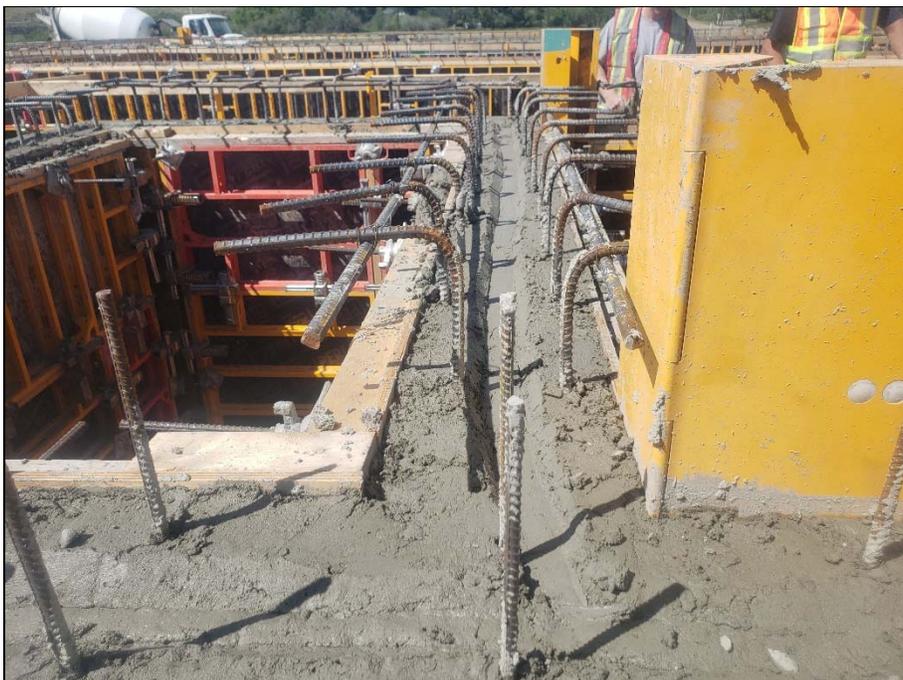
Wall concrete pour – finishing at connection to top slab.

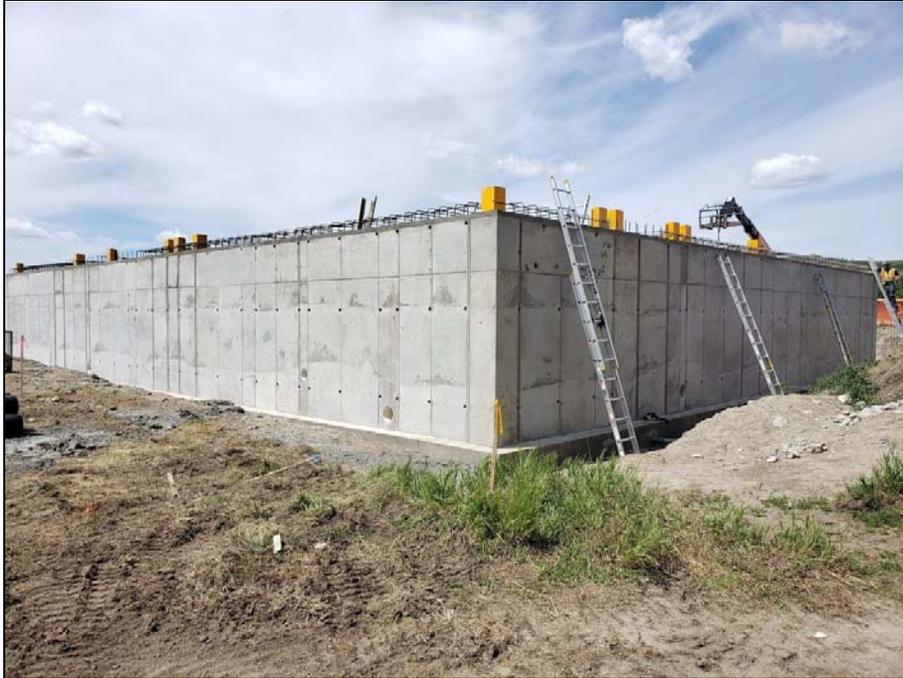
Wall formwork removed after curing.

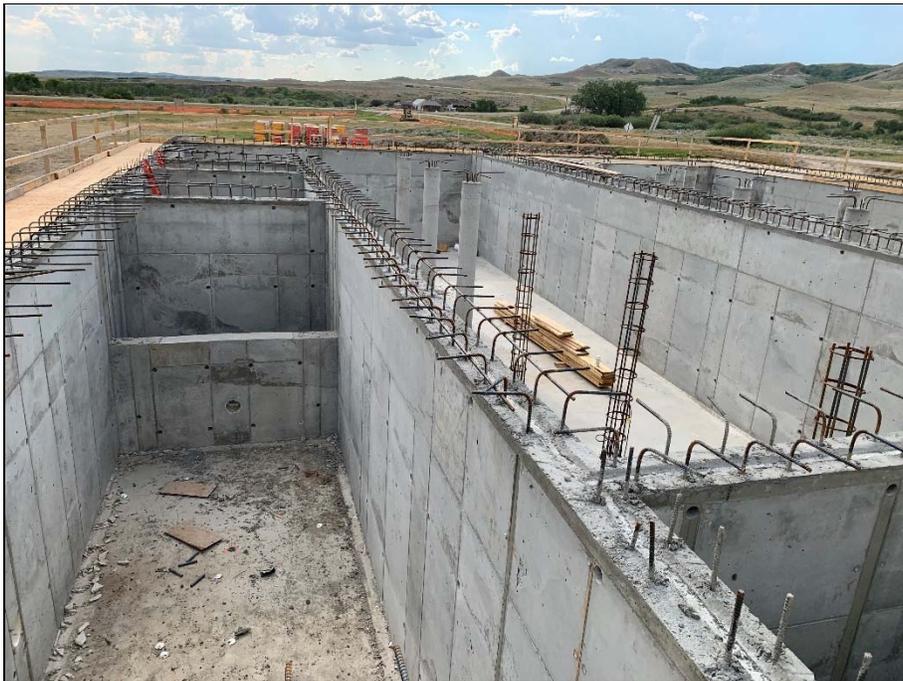
Form removal and column pours.

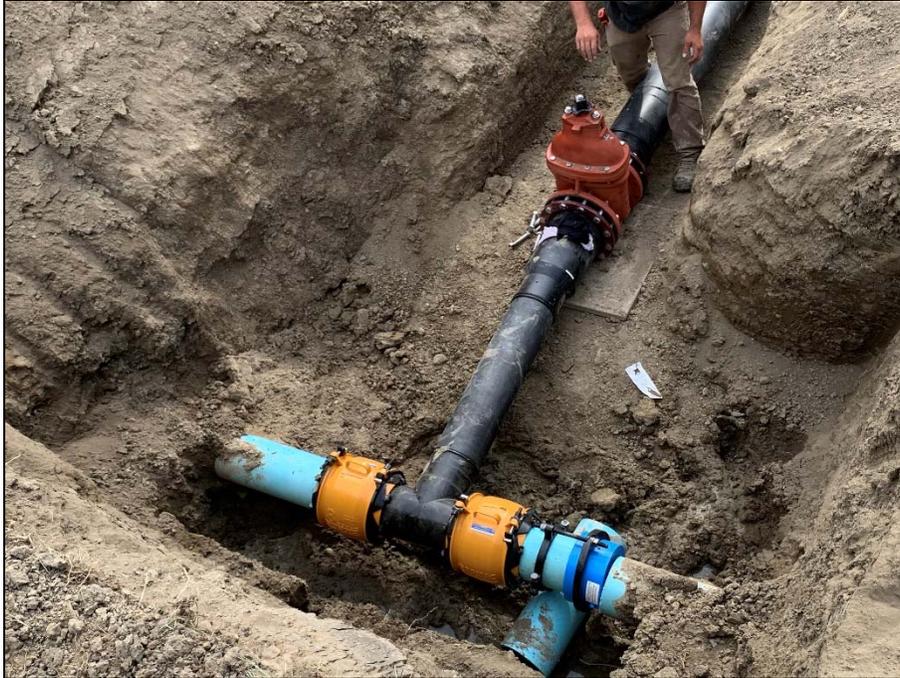
Water main tie-in and gate valve near existing water treatment plant.

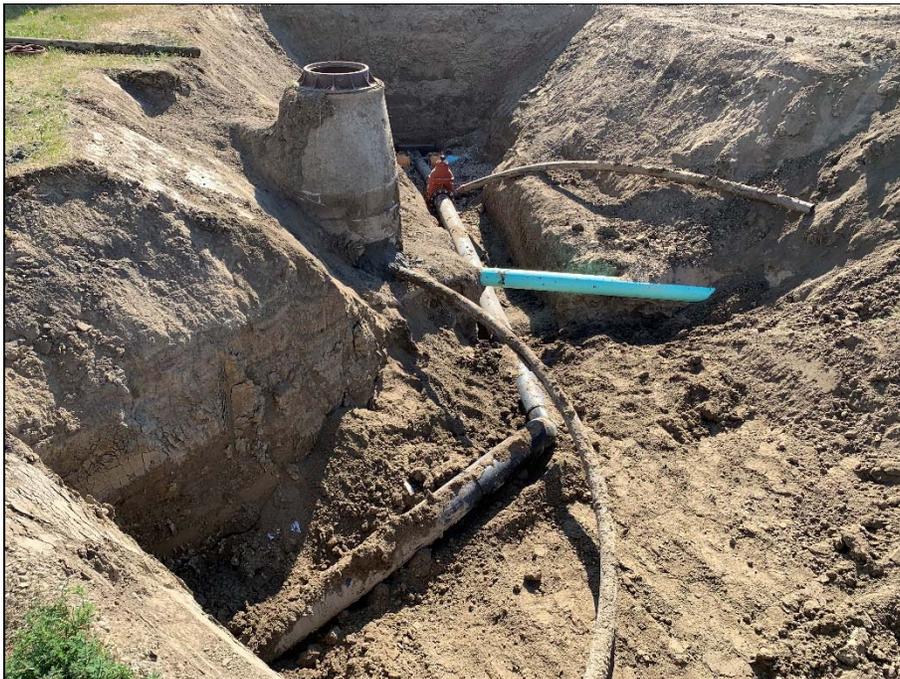
Sewer main tie-in to existing manhole near existing plant.

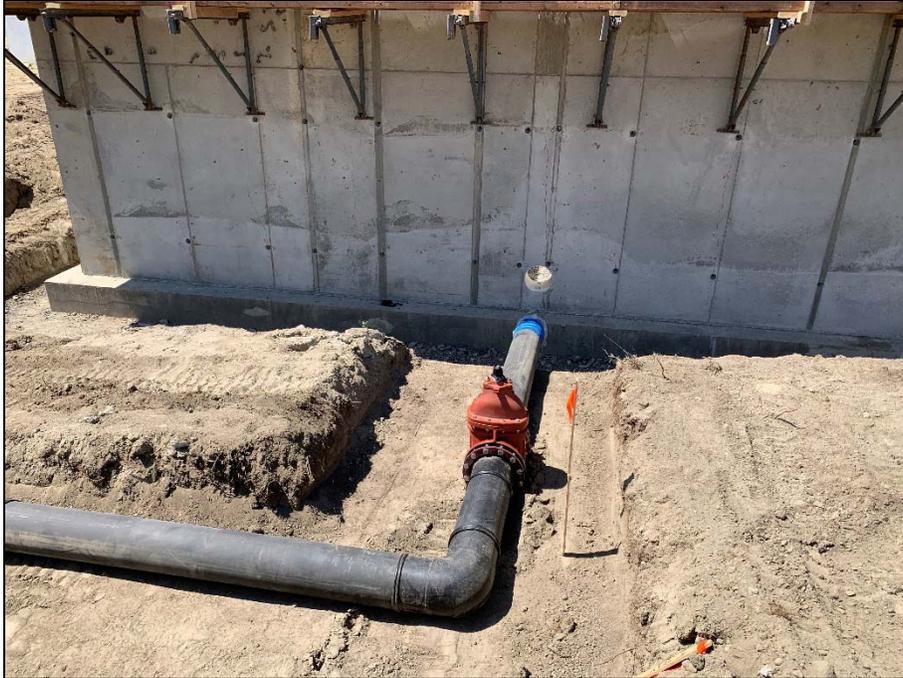
Water main and valve at new water treatment plant.

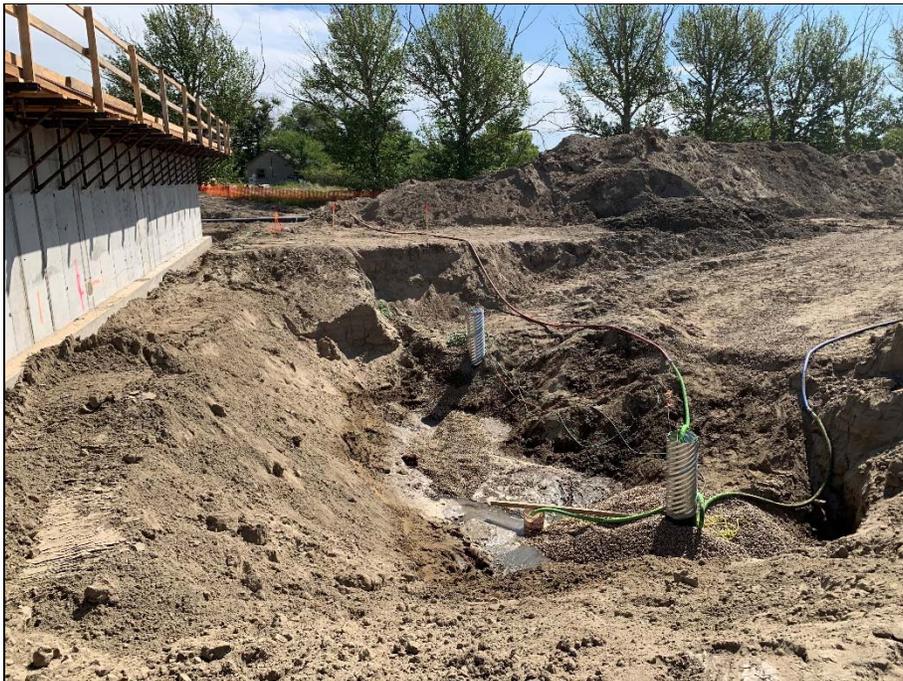
Dewatering well for reservoir intake structure next to new water plant.

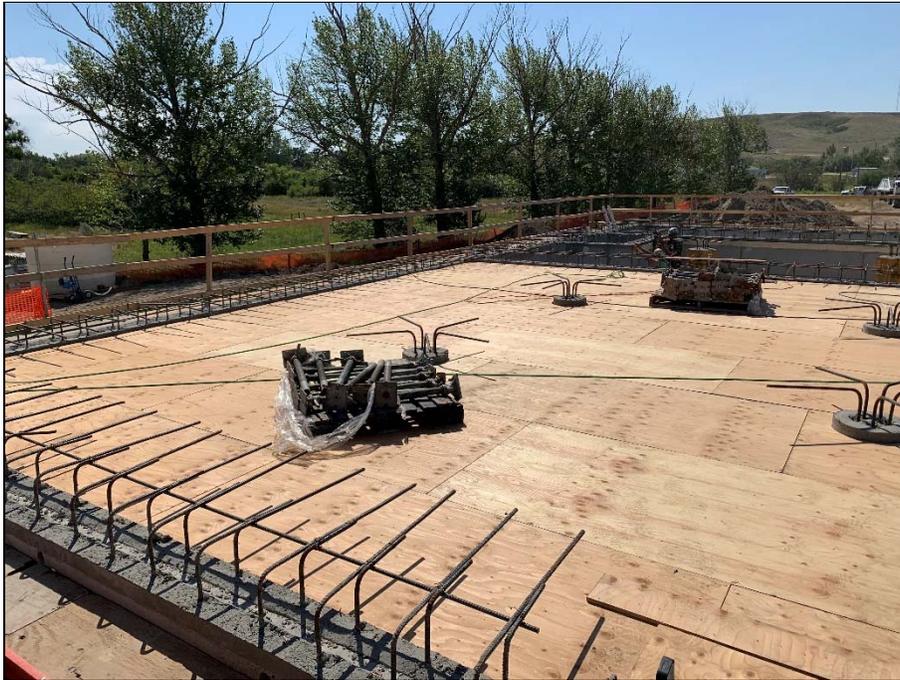
Top slab formwork underway.

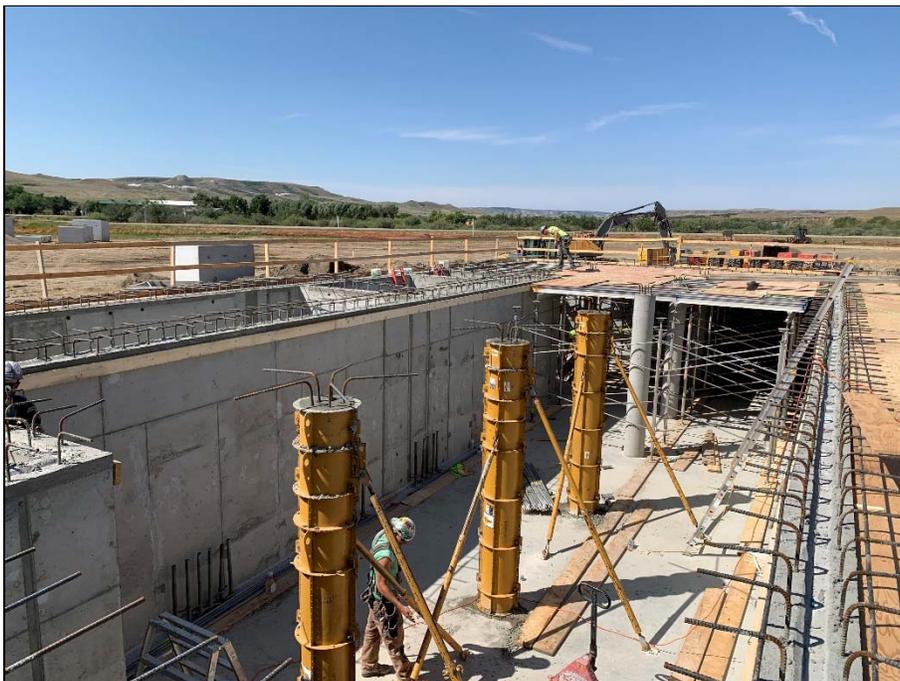
Top slab shoring and formwork underway – last few columns are poured.
